TEST REPORT

Report No. : HL80332/2006

Product Description: Chair Base

Sec. 7 Base Test - Static of ANSI/BIFMA X5.1-2002

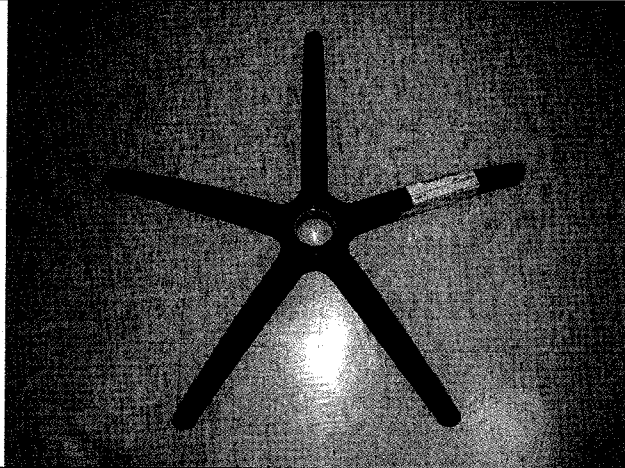
"Photo A"-sample picture

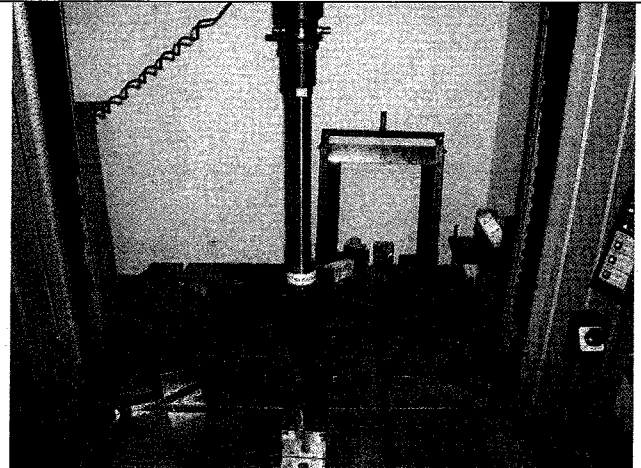
- 1) Place the base on a test platform with blocks under base arms.
- 2) A force of 11,120N (2,500 lbf) shall be applied for 1 minute.
- 3) Remove the force.
- 4) Apply a second force of 11,120N (2,500 lbf) for 1 minute.
- 5) Remove the load and evaluate the product in accordance with the acceptance level Section 7.5.
- 6) Increase the load until the chair base is broken. (Requested by the client).

"Photo B"-test method

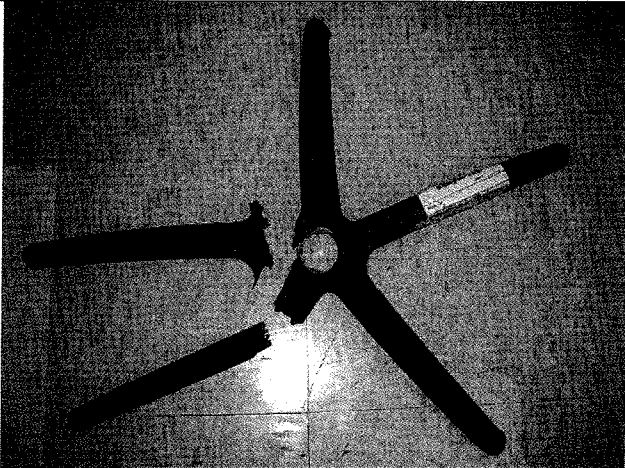
Sample	Broken load	Result	Remark
Chair Base	2858.1 lbf	<u>PASS</u>	Maximum broken load.

"Photo C"- test result

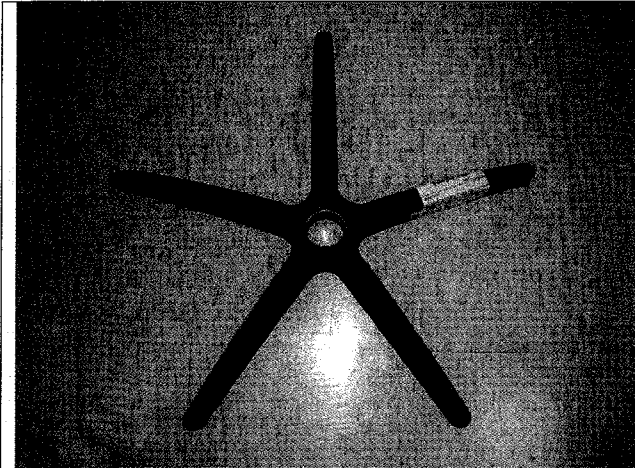
“照片 A”-樣品照片

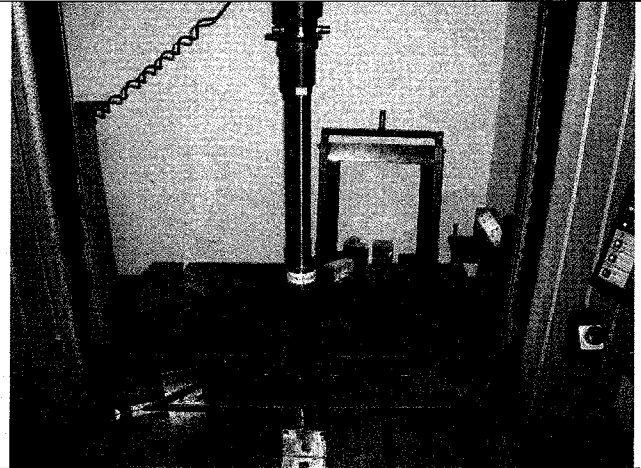
- 1) 將底座放在測試平台上，每個椅臂都用一方形鐵塊墊高。
- 2) 施加一 2500 磅(1136 公斤重) 的荷重保持 1 分鐘然後移開荷重。
- 3) 重複步驟 2) 一次。
- 4) 觀察樣品是否合於 7.5 章節中之允收水準。
- 5) 繼續增加荷重直到底座斷裂 (藉由客戶要求)。

“照片 B”-測試方法

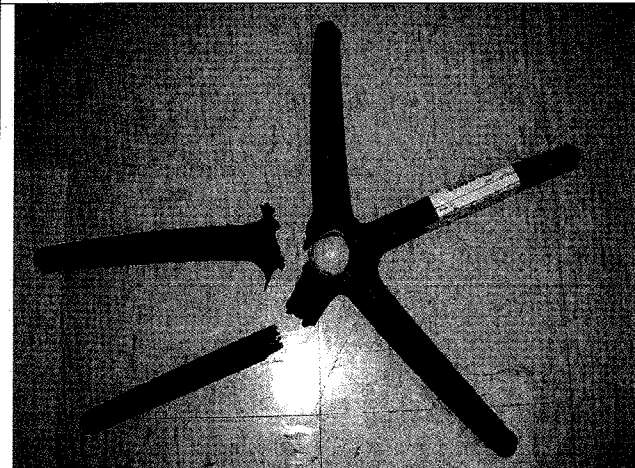
產品名稱	最大斷裂荷重	結果	附註
椅腳	2858.1 磅重	通過	最大斷裂荷重

“照片 C”-測試結果
